RE: Asbestos & Lead-Based Paint Testing
Texas Parks and Wildlife Department (TPWD)
Goliad State Park / Visitor Center, Custodian Cottage Building
108 Park Road 6
Goliad, Texas 77963
HES Project No. **16-146-9018**

**ASBESTOS & LEAD-BASED PAINT
INSPECTION REPORT**

**Goliad State Park
Custodian Cottage Building
108 Park Road 6
Goliad, Texas 77963**

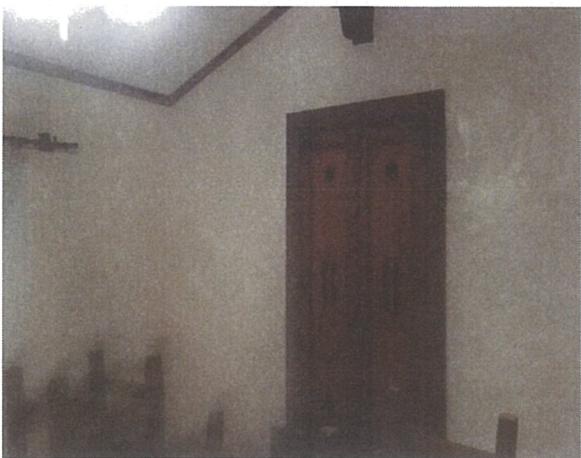
Main Door

Lead was detected above the regulatory level of **1.0 mg/cm²** in samples collected from the main door, door leading to patio, and screen doors at the facility.

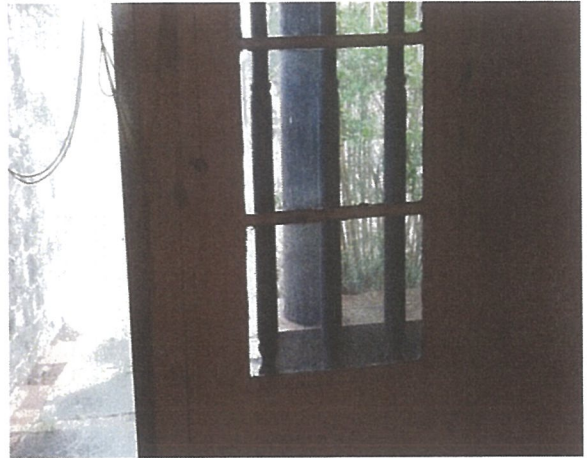
Room	Component	Color	Substrate	Hazard Category	Recommended Response Action
Entry	Door	Brown	Wood	C-1	Paint Stabilization
Patio	Door	Brown	Wood	C-1	Paint Stabilization
Patio	Screen Doors	Brown	Wood	C-1	Paint Stabilization
Side	Door	White	Wood	C-1	Paint Stabilization

Door to Patio (LBP)

Paint stabilization – all deteriorated lead-based paint on exterior and interior surfaces must be stabilized through repairs, safe paint removal and repainting.

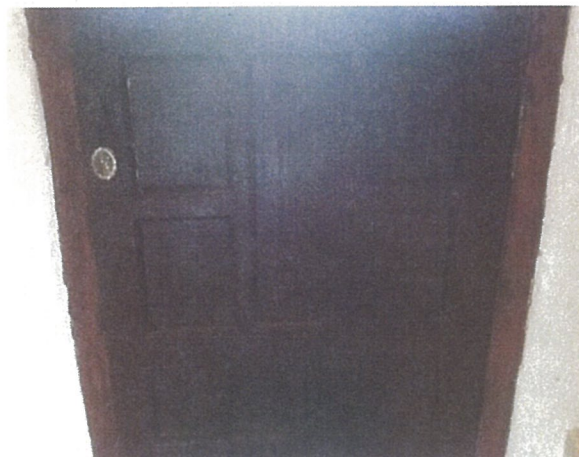
Front Door (LBP)
